ARBOR RESOURCES

**AN ARBORIST REVIEW OF THE PROPOSED
ALVES RESTAURANT
(APPLE CAFETERIA)
20625 ALVES DRIVE
CUPERTINO, CALIFORNIA**

March 9, 2012

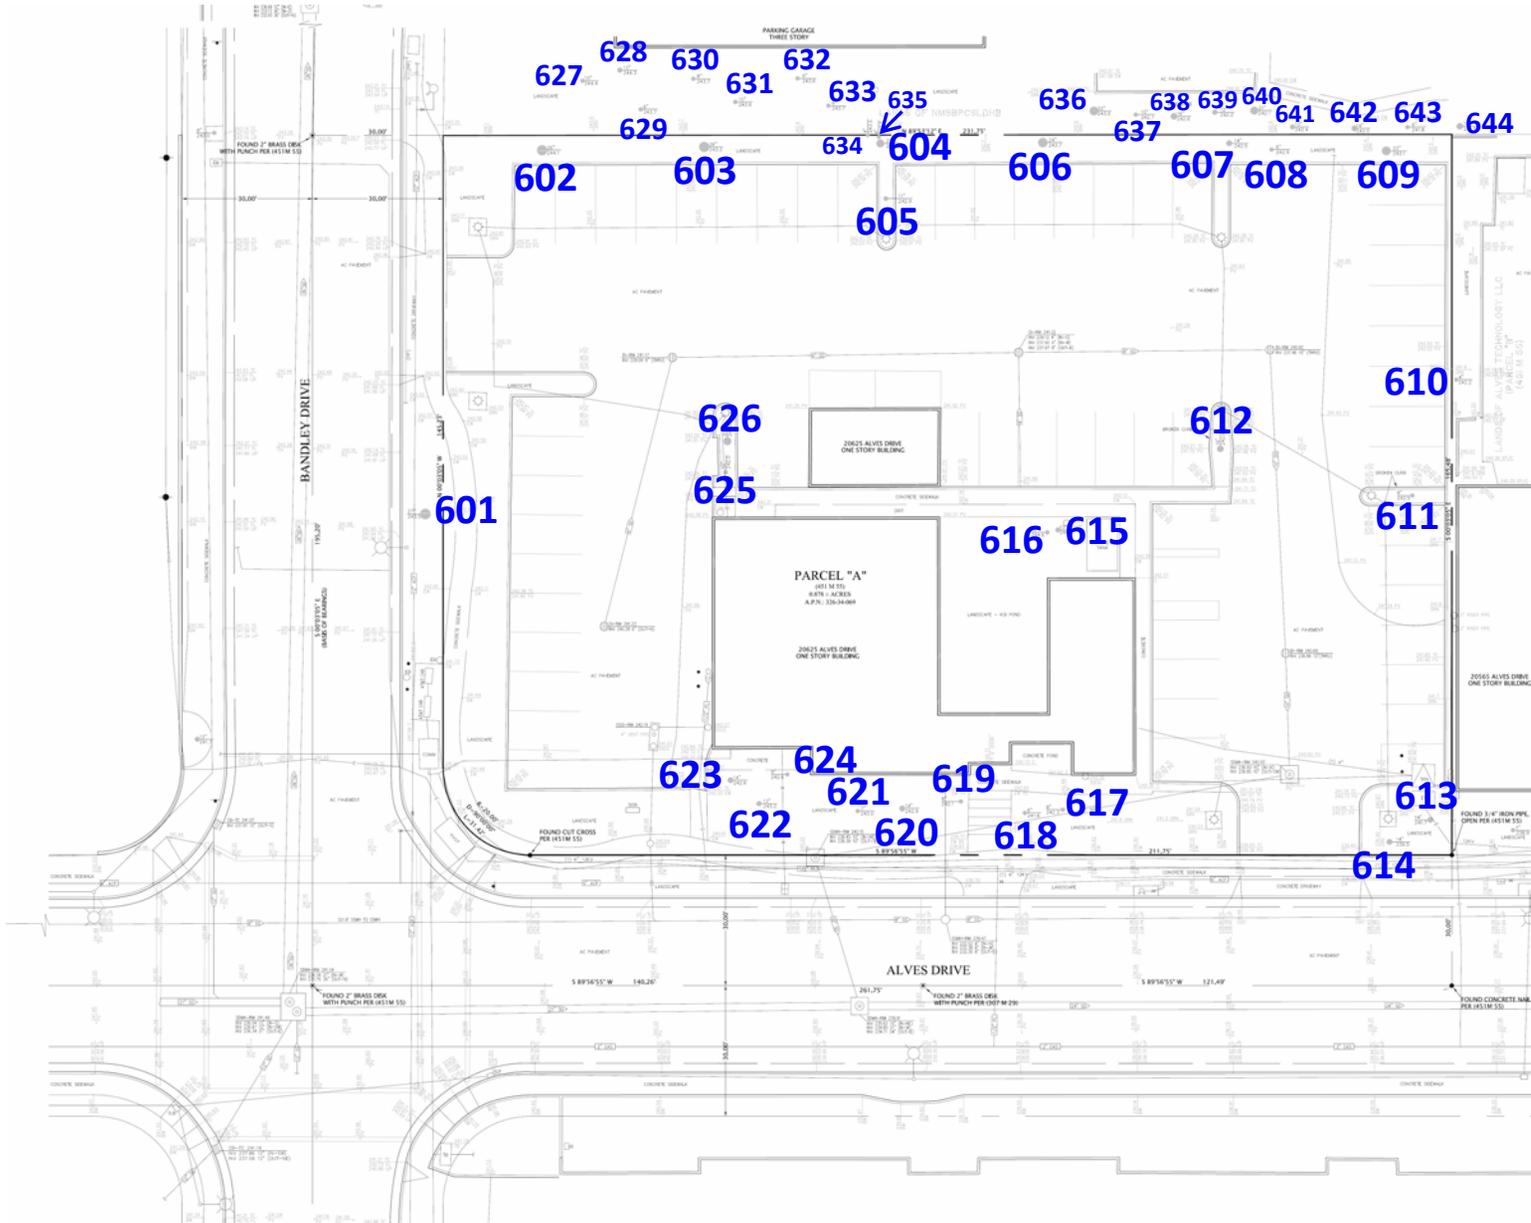
EXHIBIT A:

The **locations and assigned numbers** can be viewed on the map in **Exhibit A** (copy of the *Topographic Survey*, dated January 2012).

Seventeen (17) of the trees have trunks situated on **neighboring properties**; they include **#610, 627-633 and 636-644**. **Tree #610's** trunk is located on the eastern neighboring property, whereas the trunks of **trees #627-633 and 636-644** are situated on the northern neighboring property.

Please note that the project plans available for my review **do not identify** any of the **17 trees** on the **northern neighboring property**. Their locations and numbers can be viewed on the map in Exhibit A, but are not shown on the project plans and **should be added**.

2. The trunks of **all inventoried trees**, including the 17 on the northern neighboring property, must be added to at last **Sheets 4.0 and 6.0**. On **Sheet 6.0**, I also recommend that tree **information** presented on the **topographic survey** is shown (diameter, elevation and circle representing trunk); **tree numbers** are identified (and in a larger font than is currently shown); the **tree identified as #617** immediately northeast of tree #616 is changed to read is actual number **#612**; and **#615 and 616** are reversed.
