Walter Levison
CONSULTING ARBORIST

Tree assessment and protection recommendations
Proposed Apple café
C/o Bandley & Alves
Cupertino, CA

12/16/2011

12/19/2011

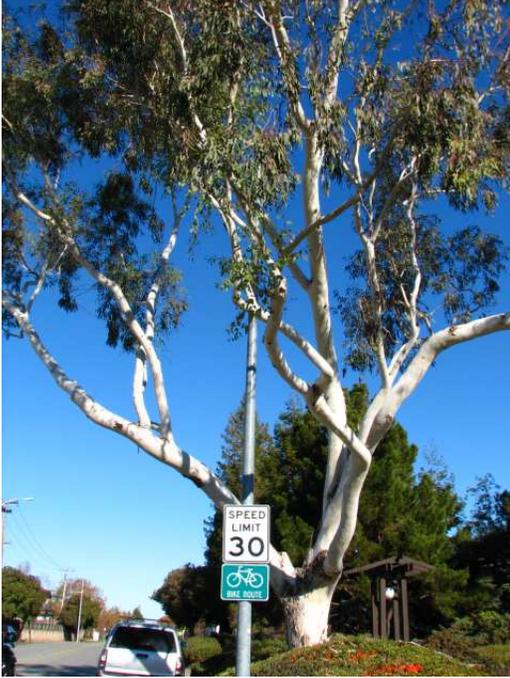
Tree #	Image 1	Image 2
601

Street tree #601 is proposed to be removed, and does present an impediment to construction based on the current site plan project. It is a low value species (river red gum) in poor overall condition. This species is susceptible to red gum lerp psyllid feeding, and the author did note the presence of this pest insect on tree #601 foliage during the field assessment (see images below, this report).

<p data-bbox="435 1157 643 1192">City street tree</p>

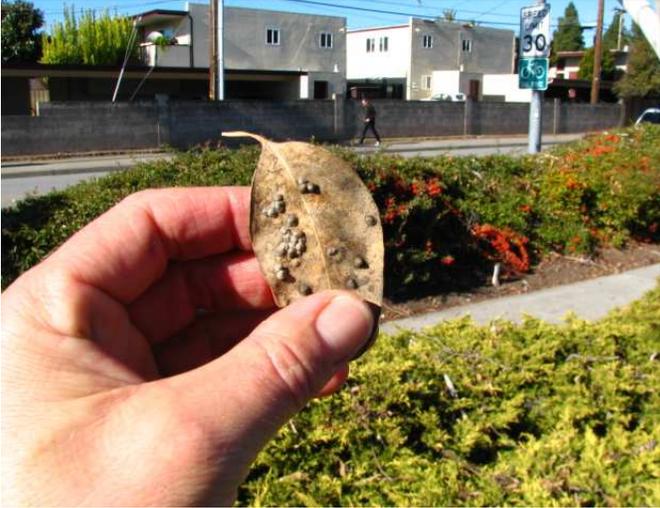
<p data-bbox="873 989 1451 1058">Red gum lerp psyllid infestation on a leaf dropped from street tree #601.</p>
602

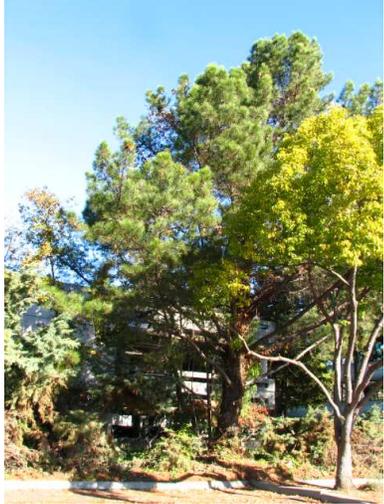
604 & 605

<p data-bbox="396 1486 675 1520">604: Pine in middle.</p> <p data-bbox="371 1562 699 1596">605: Camphor on right.</p>

603			X		26						26.0	Monterey pine	<i>Pinus radiata</i>	35/20	60/60	60% Fair	
604			X		21						21.0	Monterey pine	<i>Pinus radiata</i>	35/25	60/60	60% Fair	Possible pine pitch canker fungus infection noted ("PPC").
605			X		11						11.0	camphor tree	<i>Cinnamomum camphora</i>	25/20	50/40	45% Poor	Root system causing severe curb heave. Note one limb splitout at 6 feet above grade. Lanky limb structure.
606			X		24						24.0	Monterey pine	<i>Pinus radiata</i>	35/25	70/70	70% Good	
607			X		14						14.0	Monterey pine	<i>Pinus radiata</i>	35/12	70/65	68% Fair	
608			X		6						6.0	pink flowering ironbark eucalyptus	<i>Eucalyptus sideroxylon</i> 'Rosea'	30/5	40/20	25% Very Poor	Stunted in shade of surrounding larger tree specimens. S-trunk form.

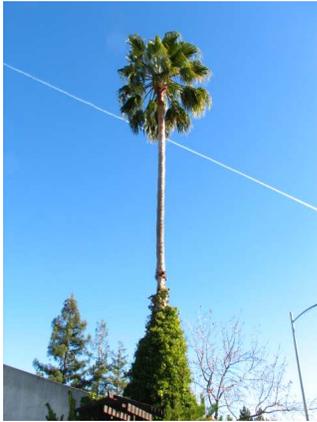
613

- 613: Mexican fan palm in good overall condition.
- 619: Weeping blue atlas cedar in good overall condition.
- 621: Japanese maple in good overall condition.
- 623: Mexican fan palm in good overall condition.
- 626: Mexican fan palm in good overall condition.

Transplant Candidate

Consider transplanting five (5) trees 613, 619, 621, 623, and 626. Call Tree Movers of Mountain View for quotes.

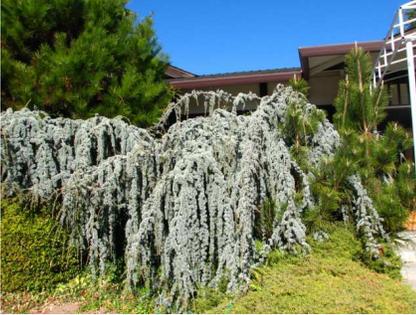
<p>619</p>

<p data-bbox="386 1058 691 1094">Transplant Candidate</p>	
<p>620 & 621 (R to L)</p>

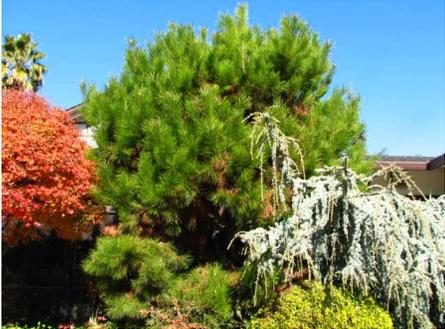
<p data-bbox="280 1503 797 1537">Maple #621 is Transplant Candidate</p>

620			X		14						14.0	Pine species	<i>Pinus sp.</i>	15/15	35/40	37% Poor	Needles 6 inches long in 3's. Tree exhibits western gall rust fungus infection, and possibly pine pitch canker infection as well.
621			X		4	3	3	2	1		13.0	Japanese maple	<i>Acer palmatum</i>	10/10	80/70	75% Good	Topped in past. Good transplant candidate.
622			X		12						12.0	Japanese flowering cherry cultivar	<i>Prunus serrulata</i> (Cult.)	10/12	60/45	55% Fair	Topped in past.
623			X		14						14.0	Mexican fan palm	<i>Washingtonia robusta</i>	60/8	80/70	77% Good	No visible issues biotic or abiotic. Transplant?
624			X		9						9.0	Ginkgo biloba	<i>Ginkgo biloba</i>	25/15	80/80	80% Good	Good single leader form.
625			X		3	3	3	3	2	2	16.0	Japanese flowering cherry cultivar	<i>Prunus serrulata</i> (Cult.)	12/12	40/30	35% Poor	Root system constricted in planter, resulting in J-form root growth.
626			X		20						20.0	Mexican fan palm	<i>Washingtonia robusta</i>	60/8	80/80	80% Good	No abiotic or biotic issues noted. Transplant?

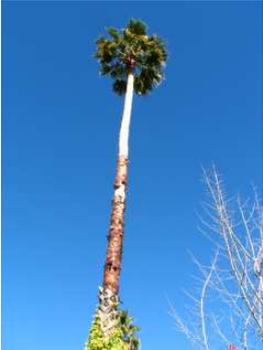
<p>Transplant Candidate</p>	
624

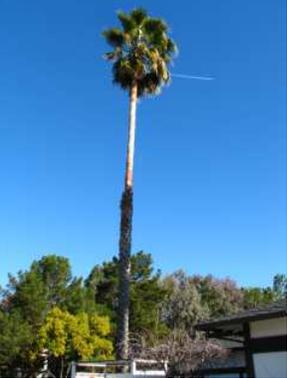
626

<p data-bbox="386 1234 691 1268">Transplant Candidate</p>

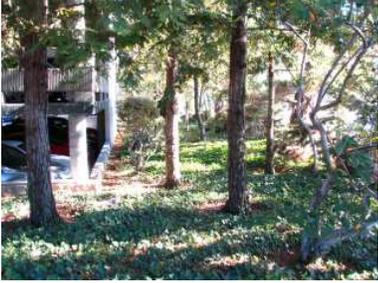
Tree #	Image 1	Image 2
627, 628, 629

<p data-bbox="277 682 799 972">Looking east along the neighbor tree planting area. This area is irrigated, but appears to be experiencing soil moisture deficit (SMD) due to inadequate supplemental water volume additions for the high water use species growing in this area (i.e. coast redwoods, white alder).</p> <p data-bbox="289 1010 789 1148">Irrigation of the neighbor redwoods and alders should be increased throughout the planting area during site plan work.</p>

629	Neighbor tree			I	6						6.0	coast redwood	<i>Sequoia sempervirens</i>	25/8	70/70	70% Good	Soil moisture deficit. Increase irrigation if retained. Located 10 feet from proposed garage excavation. Appears to be fully retainable given its small diameter trunk. Use trunk buffer and increased irrigation during site plan work.
630	Neighbor tree			I	8						8.0	white alder	<i>Alnus rhombifolia</i>	35/25	75/50	60% Fair	Trunk leans west. Needs increased irrigation. Garage excavation will occur at 17 feet from trunk. Tree appears to be fully retainable. Use trunk buffer and increased irrigation during site plan work.
631	Neighbor tree			T, I	10						10.0	white alder	<i>Alnus rhombifolia</i>	35/25	75/45	50% Fair	Tree topped in past. Needs training pruning and irrigation upgrades. Proposed garage excavation will occur at 12 feet from trunk. Tree should be retainable, but given its condition of 50%, it will need to be monitored during construction for declining vigor. Use trunk buffer and increased irrigation during site plan work.

- a) IRRIGATION: Existing neighbor irrigation shall be increased to supply regular water to all trees being retained. Frequency should be approximately 1x/week. An increase in duration of each watering event will increase the effective volume of water applied to the trees.

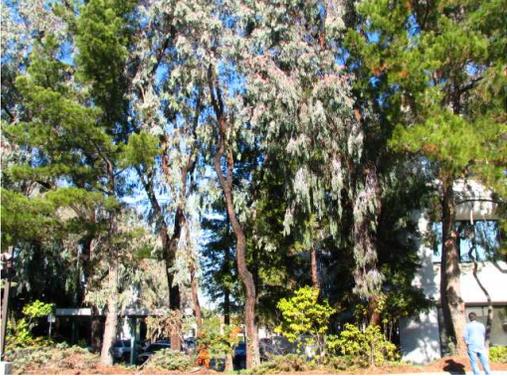
- Pink flowering ironbark eucalyptus is an important winter nectar source for bee and hummingbird species. However, it exhibits a genetically-determined structural defect of narrow-forked codominant mainstems and limbs which causes many specimens of the species to break apart prematurely, effectively shortening the useful lifespan of the tree. It is considered a moderate to high risk tree requiring that codominant mainstems be removed to eliminate narrow forks, and endweight reduction pruning be performed to reduce branch endweight.

<p data-bbox="272 779 802 921">Looking north at pink flowering ironbark eucalyptus specimens in the neighbor planting area just north of the Apple property boundary.</p>

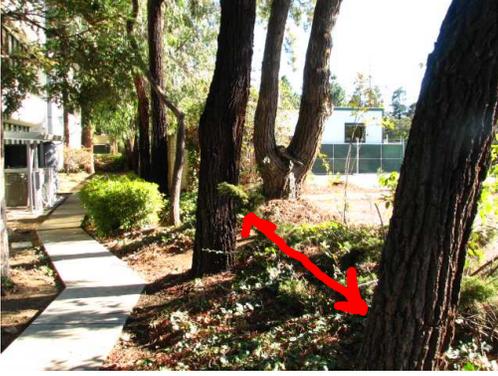
<p data-bbox="894 774 1429 844">Looking directly east at pink flowering ironbarks #609, 641, 642, 643, 644.</p> <p data-bbox="836 884 1485 1024">The property boundary is roughly indicated by the red arrow, with the Apple property parking lot to the right, and the neighbor's property with concrete sidewalk to the left.</p>

641	Neighbor tree	X			12						12.0	pink flowering ironbark eucalyptus	<i>Eucalyptus sideroxylon</i> 'Rosea'	45/20	65/55	50% Fair	Trunk leans south over Apple property. Old splitout wound noted at 18 feet above grade. Garage excavation will occur at 6 feet from trunk, making this a good removal candidate.
642	Neighbor tree	X			14						14.0	pink flowering ironbark eucalyptus	<i>Eucalyptus sideroxylon</i> 'Rosea'	55/45	80/60	70% Good	Tree was previously topped. Codominant mainstems fork at 25 feet above grade. Garage excavation will occur at 6 feet from trunk, making this tree a good removal candidate.
643	Neighbor tree	X			6						6.0	pink flowering ironbark eucalyptus	<i>Eucalyptus sideroxylon</i> 'Rosea'	25/6	0/0	0% Dead	Dead tree. Author suggests removal of this dead tree.
644	Neighbor tree	?		T, I	16						16.0	pink flowering ironbark eucalyptus	<i>Eucalyptus sideroxylon</i> 'Rosea'	55/30	80/55	68% Fair	S-form mainstem at 25 feet above grade. Good TDE. Tree has received clearance pruning on north side of canopy to clear the existing neighbor office building, which is good since it reduced tension stresses for the Apple garage-side of root system to deal with after excavation occurs on south. Tree is located 8 feet from proposed garage excavation, making this tree retainable, but would need to be <u>monitored for decline and trunk lean / root plate rotation</u> . Use trunk buffer and increased irrigation during construction.
