Walter Levison
CONSULTING ARBORIST

Tree assessment and protection recommendations
Proposed Apple café
C/o Bandley & Alves
Cupertino, CA

12/16/2011

12/19/2011

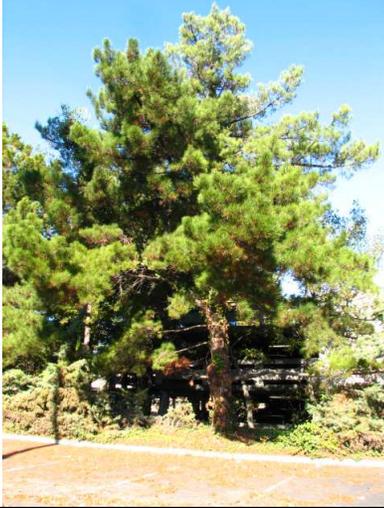
Tree #	Image 1	Image 2
603

603			X		26						26.0	Monterey pine	<i>Pinus radiata</i>	35/20	60/60	60% Fair	
604			X		21						21.0	Monterey pine	<i>Pinus radiata</i>	35/25	60/60	60% Fair	Possible pine pitch canker fungus infection noted ("PPC").
605			X		11						11.0	camphor tree	<i>Cinnamomum camphora</i>	25/20	50/40	45% Poor	Root system causing severe curb heave. Note one limb splitout at 6 feet above grade. Lanky limb structure.
606			X		24						24.0	Monterey pine	<i>Pinus radiata</i>	35/25	70/70	70% Good	
607			X		14						14.0	Monterey pine	<i>Pinus radiata</i>	35/12	70/65	68% Fair	
608			X		6						6.0	pink flowering ironbark eucalyptus	<i>Eucalyptus sideroxylon</i> 'Rosea'	30/5	40/20	25% Very Poor	Stunted in shade of surrounding larger tree specimens. S-trunk form.
